**Flood Control Project Maintenance
Levee Inspections**

Fall 2018 Levee Maintenance Deficiency Summary Report

Sacramento River Basin

Reclamation District No. 0070 Meridian

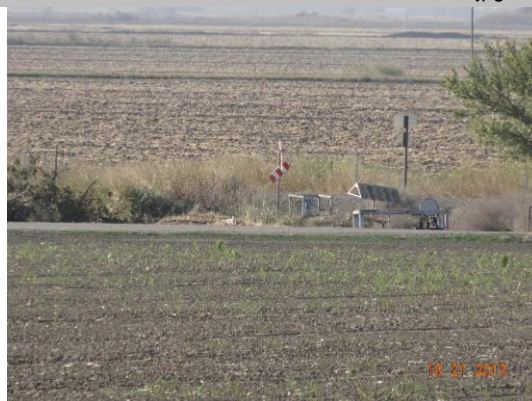
Photo 3 of 3 : UCIP_FA_2018_23463_40620.jpg

Comment Code					
Inspector Comment					
FS_ID:23463 DS_ID:21347 EP_NO: 3804 Repair Type: Non-Urgent Crossing Status: Indicator Found UCIP Comments: Unable to confirm if the indicators that were found in the field correspond to this crossing. Will need to contact PG&E to confirm location of crossing. Photos will need to be updated if the photos attach do not correspond to this crossing. This crossing is referenced in the USACE Periodic Inspection as item USACE_CESPK_MRD1_2012_p_0304 for 12 inch gas pipe. Coordinates between DWR UCIP and USACE PI are approximately 630 feet apart. FIELD_STRUCT_DESC: 12-inch coated steel natural gas pipeline through the levee, 3.6 feet below the crown. Concrete cutoff wall around the pipe at the center of the levee. Marker sign on the waterside (WS) shoulder. Rock revetment on the WS slope. (Plans for installation of a 12-inch gas collecting line through the levee authorized under Permit No. 3804, 1961 - Pacific Gas and Electric Company [PG&E]). [Additional Reference(s): DWR Levee Log, 2007]. FS Date: 10/21/2013

View of gas line markers approximately 900 feet away.

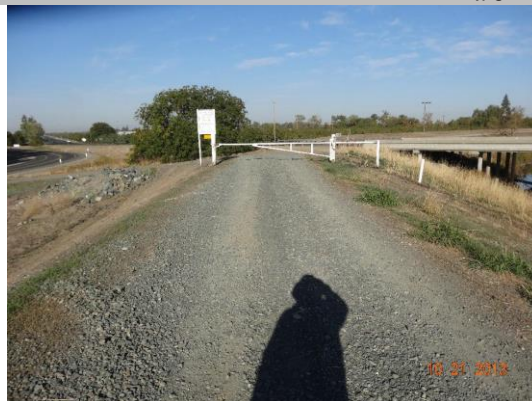
Photo 2 of 3 : UCIP_FA_2018_23503_40780.jpg

Comment Code						
Inspector Comment						
FS_ID:23503 DS_ID:21351 EP_NO: 3686 Repair Type: Non-Urgent Crossing Status: Found UCIP Comments: Dense vegetation limits the inspector's visibility to identify signs of pipe failure (leaks) along the waterward slope. Recommend removing vegetation along pipe alignment to conduct proper inspection of structure and appurtenances. Unable to find the gate valve on landward side. Walkway on waterward side in bad shape. This crossing is referenced in the USACE Periodic Inspection as item USACE_CESPK_MRD1_2012_p_0300 for 18 inch pipe. Pipe on LS is 10 inch not 18 inch. SEE UCIP DS_ID 21350 for details pertaining to 18 inch pipe. FIELD_STRUCT_DESC: 10-inch irrigation discharge pipe of an unknown material through the levee, 14.8 feet below the crown. Electrical conduit through the levee, 1 foot below the crown. Pump on a pile structure in the stream. Service pole with meter and control panel at the landside (LS) toe. Slide gate with walkway on the waterside (WS) end. Gate valve on the LS end, not found during 10/21/2013 pipe inventory. Rock revetment on the WS slope. (Plans for removal of a pump on the LS and installation of a pump and two concrete piers on the WS authorized under Permit No. 3686, 1961 - Gerald A. Frye). [Additional Reference(s): DWR Levee Log, 2007]. FS Date: 10/21/2013

View of levee crown looking downstream.

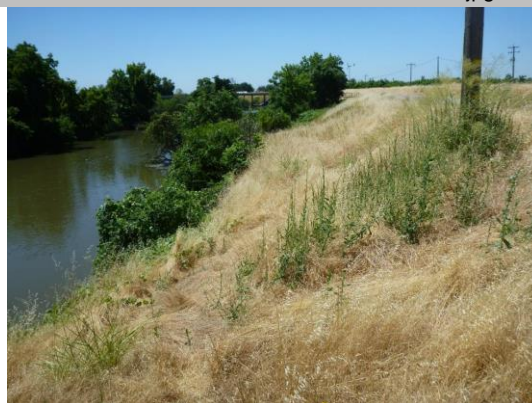
Photo 1 of 3 : LEVAL_FA_2018_154_1686.jpg

LM Start	0.76	Rating **	A/W	Issue No.	36
LM End	0.76	Issue Type +	Ma	Location *	
Category	Supplemental			GPS Latitude/Longitude	
				Start	End
Item	2017 Storm Damage			39.145240 °	39.145240 °
				-121.842650 °	-121.842650 °
DWR ID	DWR_RD0070_01_f_2017_36				
Comment Code					
Inspector Comment					
Levee Evaluation Comments					
Description:					
Site ID No:154					
Site Designation:RD 70-03					
Repair Type: Erosion					
Rating:Area of Concern					
Field Date:7/17/2017					
Notes:

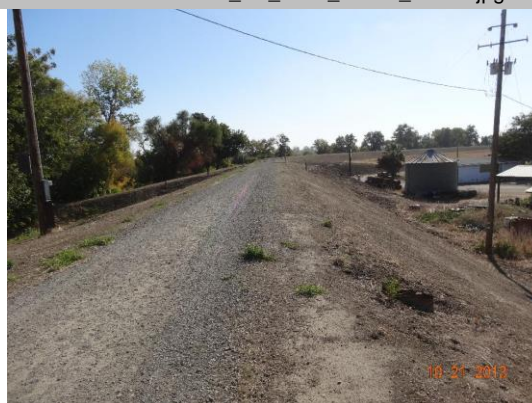
Photo 1 of 3 : UCIP_FA_2018_23508_40821.jpg

Comment Code						
Inspector Comment						
FS_ID:23508 DS_ID:21336 EP_NO: N/A Repair Type: Non-Urgent Crossing Status: Found UCIP Comments: Need to find owner to determine if crossing is still in use. If crossing is no longer in use owner will need to coordinate with DWR inspector and CVFPB to remove according to Title 23 requirements. Evidence of high burrow activity on waterward side recommend addressing issue. This crossing is referenced as USACE_CESPK_MRD1_2012_p_0230 in the USACE's PI report for no USACE recommendation letter available -- correction pipe is 12-inch not 16-inch. FIELD_STRUCT_DESC: 12-inch irrigation discharge pipe of an unknown material through the levee, 4 feet below the crown. Siphon breaker on the landside (LS) slope. 7-foot by 9-foot concrete distribution box at the LS toe. Service pole on the waterside (WS) slope. Pump on a concrete sump on the WS slope. Overhead power line crosses the levee. (Plans for the installation of a 12-inch steel irrigation pipe through the levee authorized under Permit No. 613, 1934 - Waldo M. Nall. Plans to retain a 12-inch pipe through the levee, 4 feet below the crown, pump, and siphon breaker authorized under Automatic Board Order (ABO) issued as Permit No. 9948, 1974 - Edward E. and Doris M. Nall). [Additional Reference(s): DWR Levee Log, 2007]. FS Date: 10/21/2013

View of levee crown looking upstream from crossing.

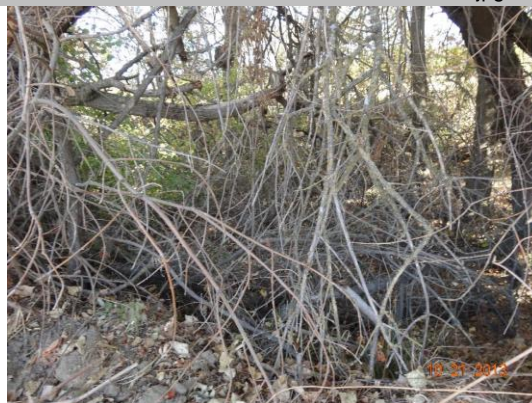
Photo 3 of 3 : UCIP_FA_2018_23530_40971.jpg

Comment Code						
Inspector Comment						
FS_ID:23530 DS_ID:21322 EP_NO: N/A Repair Type: Non-Urgent Crossing Status: Indicator Found UCIP Comments: Unable to determine if crossing exists need to coordinate with LMA to determine if more information is available about crossing. This crossing is referenced in the USACE Periodic Inspection as item USACE_CESPK_MRD1_2012_p_0208 for concrete ditch lined within 15 feet of LS toe, no water present, and no USACE recommendation letter available. FIELD_STRUCT_DESC: 12-inch steel irrigation discharge pipe through the levee, at an unknown depth. Cutoff wall around the pipe at the center of the levee. Slide gate on each end. Pump on the waterside (WS). Concrete distribution box on the landside (LS). [Additional Reference(s): USACE Sacramento O&M Manual 134, June 1953, (Station 142+70)]. FS Date: 10/21/2013

Waterward side covered by vegetation.

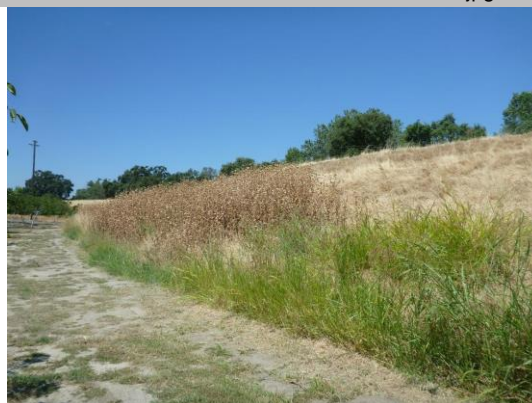
Photo 1 of 3 : LEVAL_FA_2018_153_1702.jpg

LM Start	3.18	Rating **	A/W	Issue No.	37
LM End	3.18	Issue Type +	Ob	Location *	
Category	Supplemental			GPS Latitude/Longitude	
				Start	End
Item	2017 Storm Damage			39.157480 °	39.157480 °
				-121.879250 °	-121.879250 °
DWR ID	DWR_RD0070_01_f_2017_37				
Comment Code					
Inspector Comment					
Levee Evaluation Comments					
Description:					
Site ID No:153					
Site Designation:RD 70-02					
Repair Type: Seepage (B)					
Rating:Serious					
Field Date:7/17/2017					
Notes:

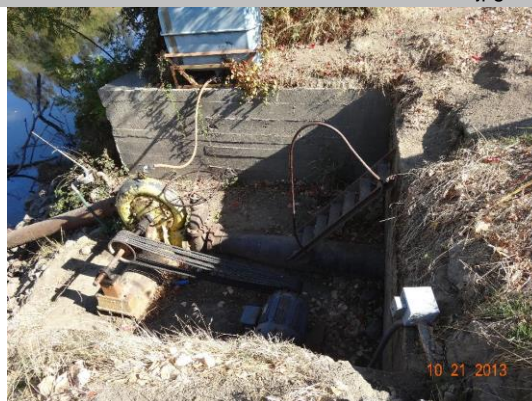
Photo 3 of 3 : UCIP_FA_2018_23506_40807.jpg

U shaped concrete box located on waterward side contains pump, motor, stairs, and pipe.

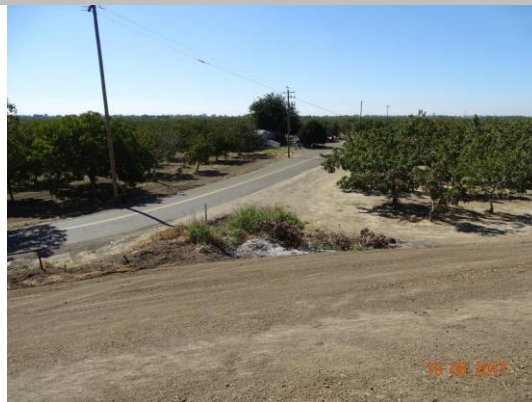
Photo 1 of 2 : FA_2018_RD0070_29_30_20180905_00006.jpg

View of the prunings along the landside toe.

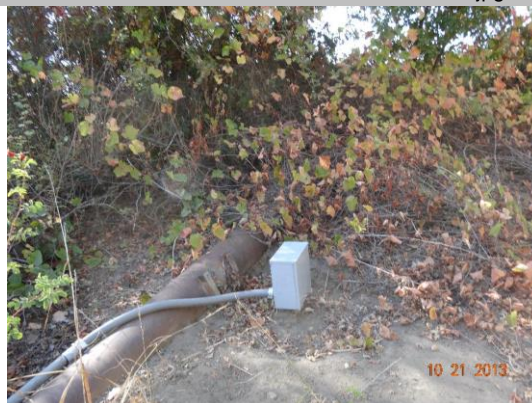
Photo 2 of 3 : UCIP_FA_2018_23519_40898.jpg

Pipe and electrical conduit exposed on levee berm.

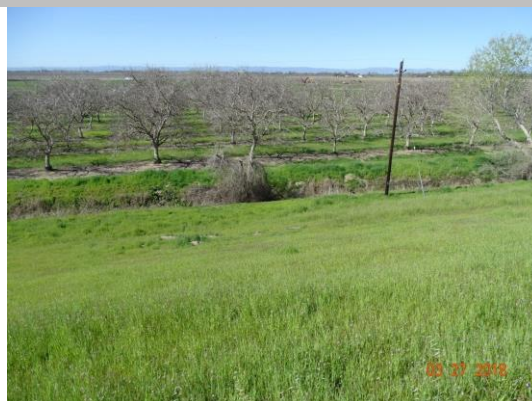
Photo 1 of 1 : FA_2018_RD0070_29_35_20180905_00010.jpg

View of the rodent holes along the landside slope.

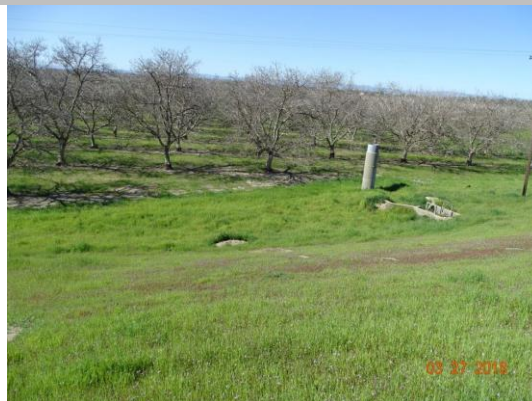
Photo 1 of 1 : FA_2018_RD0070_29_40_20180905_00019.jpg

View of rodent holes along the landside slope.

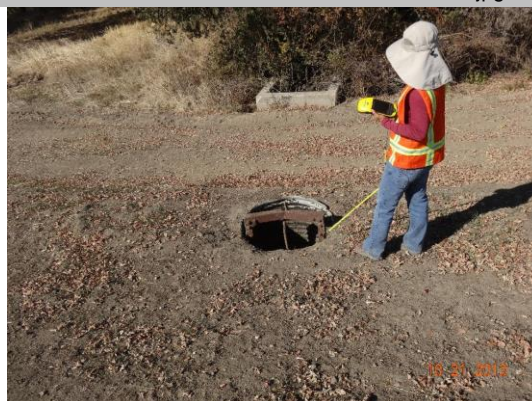
Photo 2 of 3 : UCIP_FA_2018_23529_40963.jpg

CMP riser with screw gate inside. Gate is missing the handle to close gate.

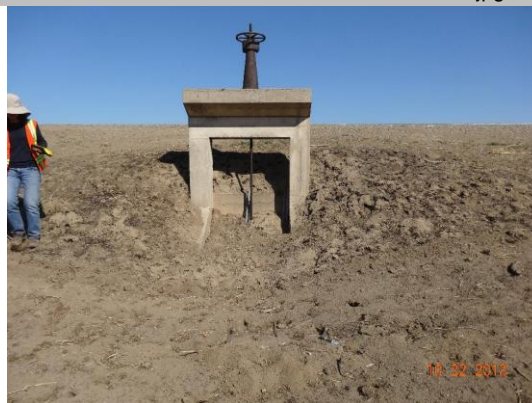
Photo 2 of 3 : UCIP_FA_2018_23892_41841.jpg

Buried screw gate located on waterward shoulder.

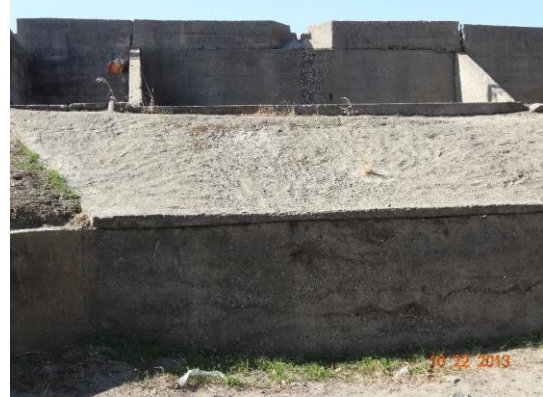
Photo 1 of 1 : UCIP_FA_2018_23960_42097.jpg

Concrete headwall located on landward side--no pipe. Only visible pipe is the pipe located at the far left (downstream end).

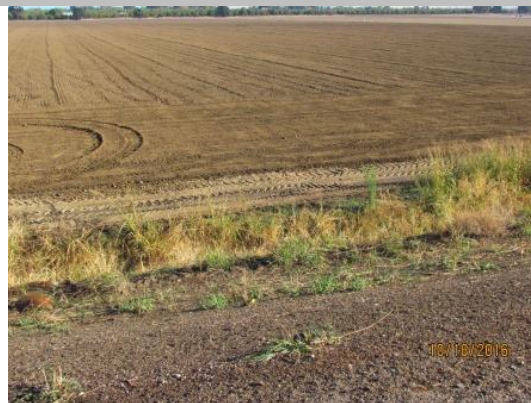
Photo 1 of 1 : FA_2018_RD0070_30_56_20180905_00009.jpg

View of a ditch at the landside toe.

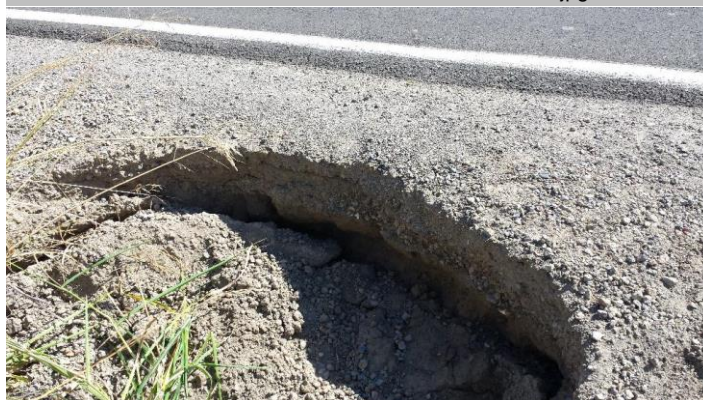
Photo 3 of 3 : UCIP_FA_2018_50007_74614.jpg

Slope damage within 2 feet of County Road.

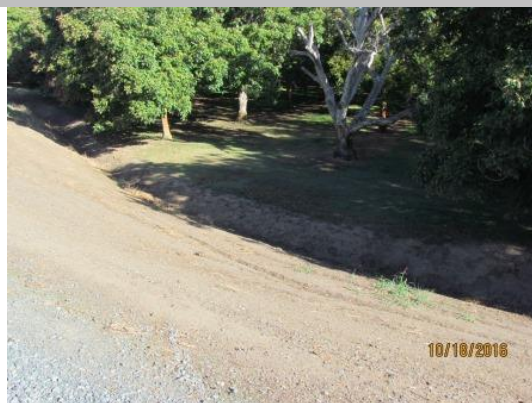
Photo 1 of 1 : FA_2018_RD0070_30_65_20180905_00014.jpg

View of a ditch along the landside toe.
